MECHANICAL RESISTANCE OF CRACKED DAM MASS CONCRETE
REPAIRED BY GROUTING: AN EXPERIMENTAL STUDY

MÉMOIRE PRÉSENTÉ EN VUE DE L'OBTENTION
DU DIPLÔME DE MAÎTRISE ÈS SCIENCES APPLIQUÉES
(GÉNIE CIVIL)

DÉCEMBRE 2012

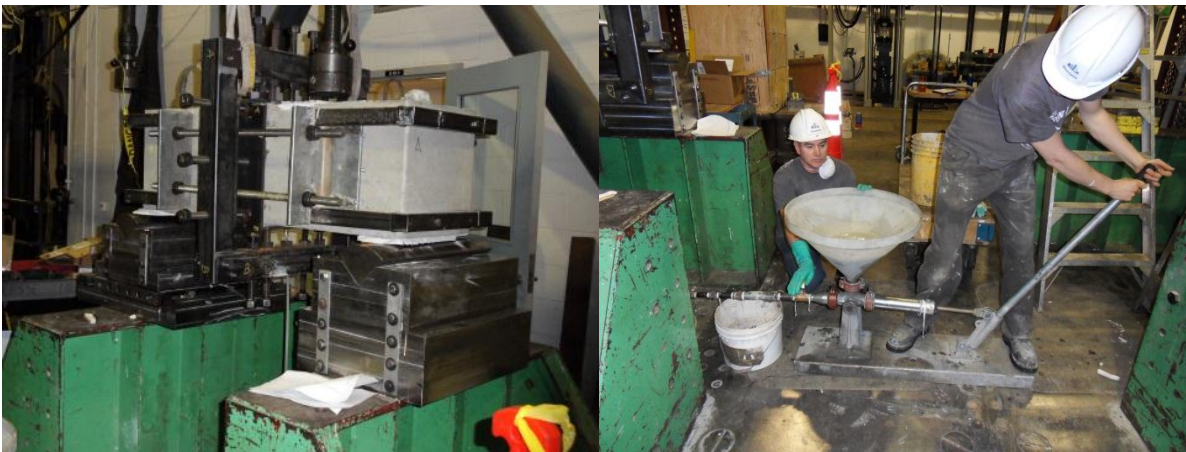
Figure 3-4: Injection and Injection Frame

The specimens were mounted with a support frame as seen in Figure 3-4. Upon failure of the specimen the crack between the two specimen halves was set to 2 mm (78.74 mil); this opening was selected so as not to impede the injection grout and to insure the best repair possible. This range of opening is representative of some of the openings at the crack mouth of BDJ. This was done with the help of 8 pairs of DEMEC points and by adjusting bolts on the 4 rods. The injection frame was installed on the specimens (A,B,C, and D) to allow the fracture to be repaired. The frame consisted of four 100 x 420 x 12 mm (4 x 16 x 1/2 in.) piece of pure gum that were held against the four sides of the specimen by steel plates. The plates were compressed onto the specimen by bolts attached to a steel frame that is installed around the specimen to seal the
